Section I

EARTHQUAKE DAMAGE

INTENSITY DISTRIBUTION AND ISOSEISMAL MAP FOR
THE MORGAN HILL, CALIFORNIA, EARTHQUAKE OF APRIL 24, 1984

PERFORMANCE OF RESIDENTIAL STRUCTURES
DURING THE MORGAN HILL EARTHQUAKE OF APRIL 24, 1984

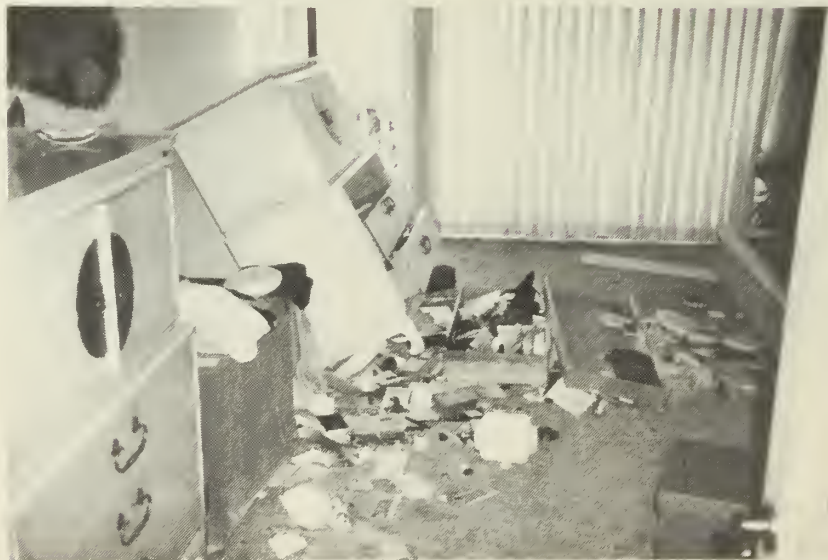
Interior damage to contents.

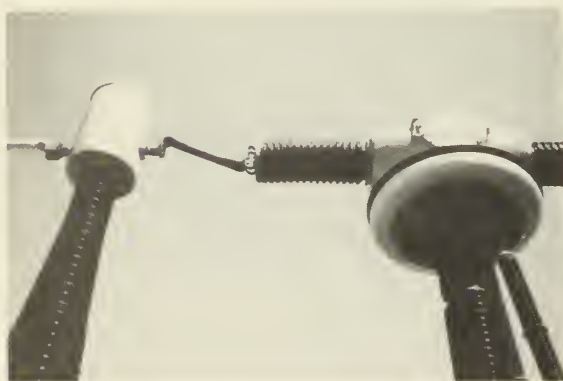
Figure 5. Circuit Breaker-Current Transformer Undamaged Connection.

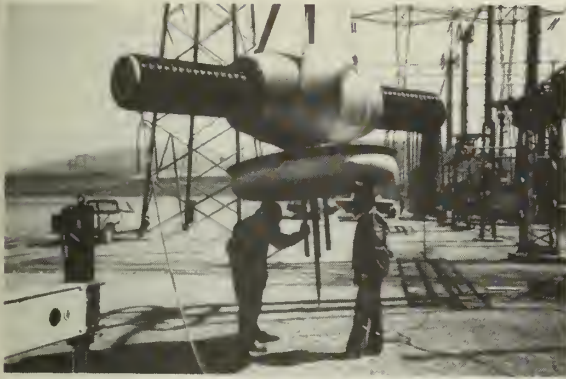
Figure 7. Interrupter Head of Live Tank Circuit Breaker.

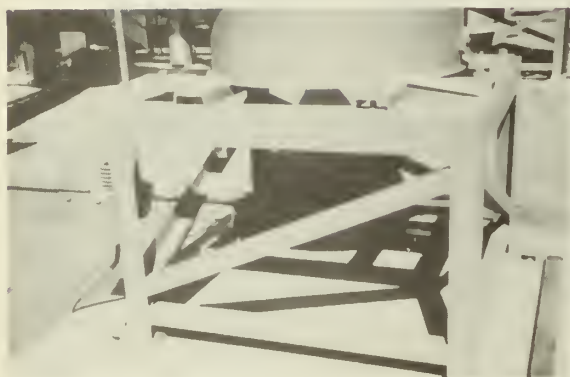
Figure 11 shows a picture of the CT mounting and its support stand. The CT is supported on four 5" channels forming a pattern similar to that shown in Figure 3. On many of the connections between the 5" channel (attached to the base of the CT and extending under it) and the CT support stand, cracked paint indicated that there was severe loading. The locations of these signs of distress are indicated by small dots in Figure 3. The rather irregular pattern may be explained by variations in the tightness of bolts which secure the channel to the CT stand. There were no signs of distress in the clips which hold the CT support stand to its foundation pad. Figure 12 shows the support stand used for the CTs on the other transmission circuit (D on Figure 1) in which no cracking of paint was observed, and the CBs were undamaged. A rough estimate of the natural frequency of the CT is 2.5 Hz, although a more realistic value is probably below 2 Hz. It is suggested that the CT may have been excited by the low-frequency ground motions, and the stiff connections, with limited play between the CB and CT, transferred load to the CB causing its failure. Supporting evidence would be that the more rigid CT supports shown in Figure 12 raised its frequency so that there was less interaction with the ground motion and less deflection. Also, all interrupter heads with damaged columns (this is also true for the Metcalf substation discussed below) were immediately adjacent to the CT. Not all evidence supports this conclusion. First, if there was vibration of the CT, why wasn't the paint cracked on both sides of the CT support rather than the rather irregular pattern observed? Also, how does one explain the failure of diagonal braces on interrupter columns not adjacent to the CT,

Figure 11. Current Transformer Mounting and Support Stand.

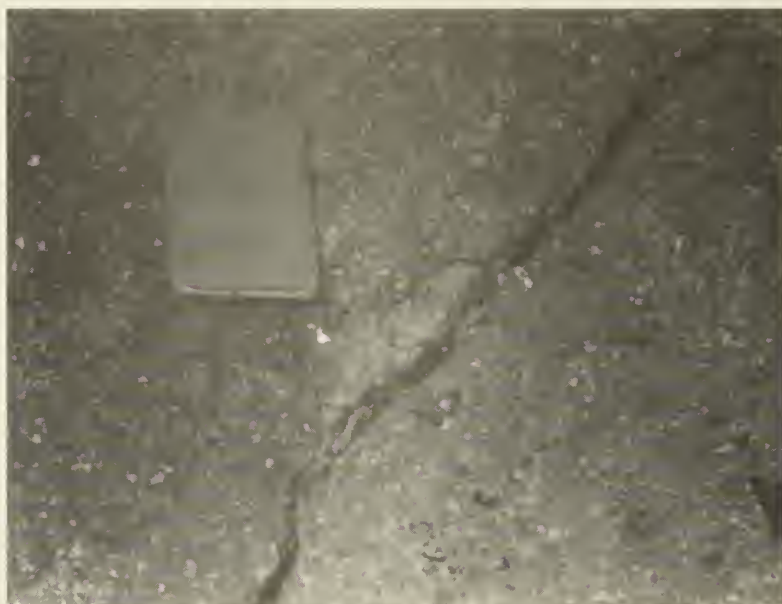
Leroy Anderson Dam-cracking on the crest road.

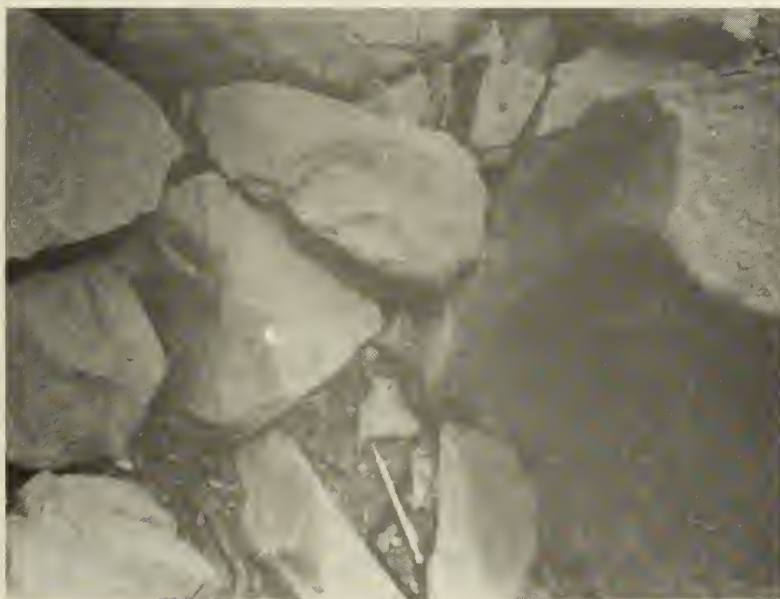
Coyote Dam-cracking on the upstream slope.

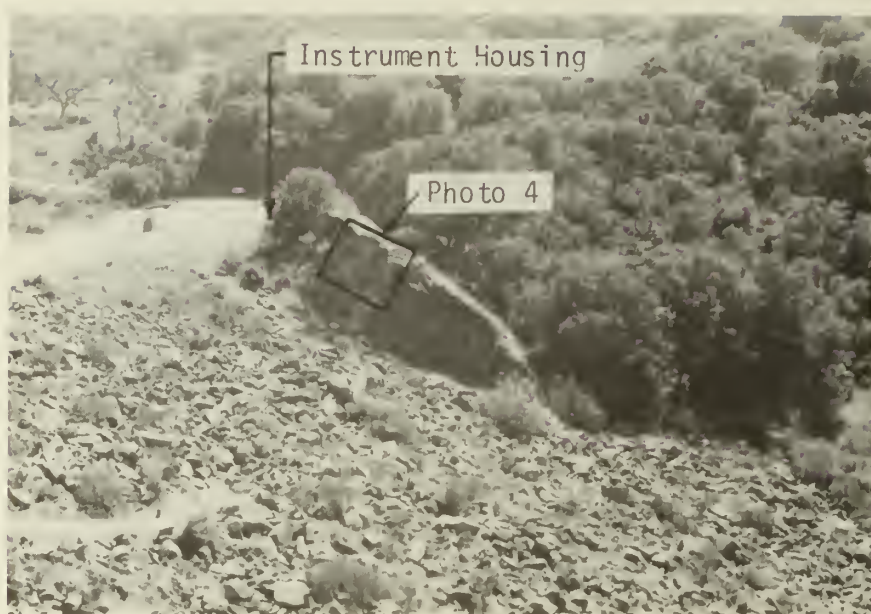
Photo 3 - Southwest View of Rock, Location of Rock Fall, and Instrument Location

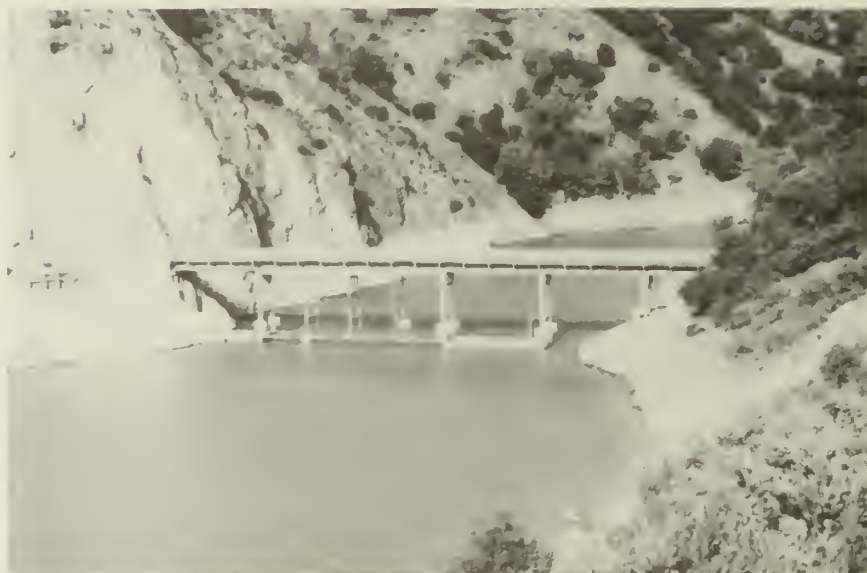
PHOTO 1 County bridge over Anderson Reservoir.

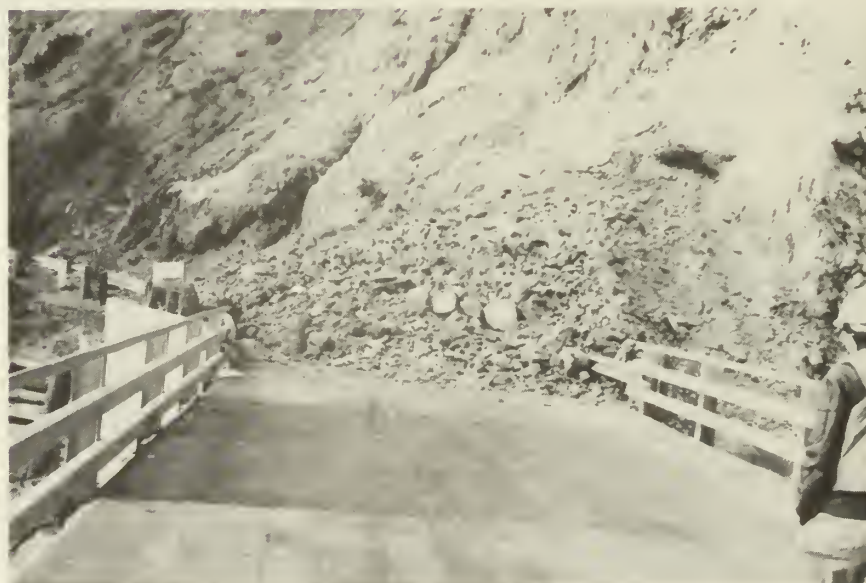
PHOTO 2 Rockslide at north end of bridge near
Abutment 6. Br. No. 37C-166

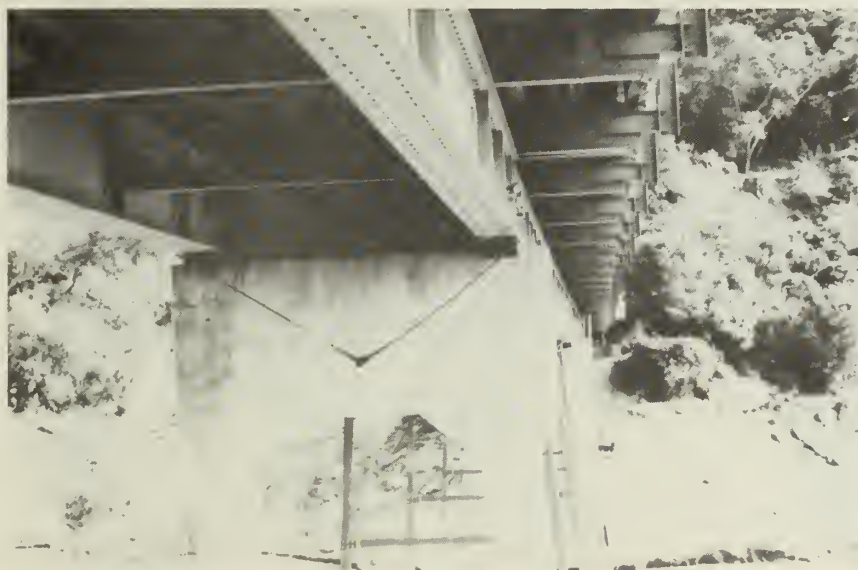
PHOTO 3 Transverse cable restrainers at
Pier 5. Br. No. 37C-166

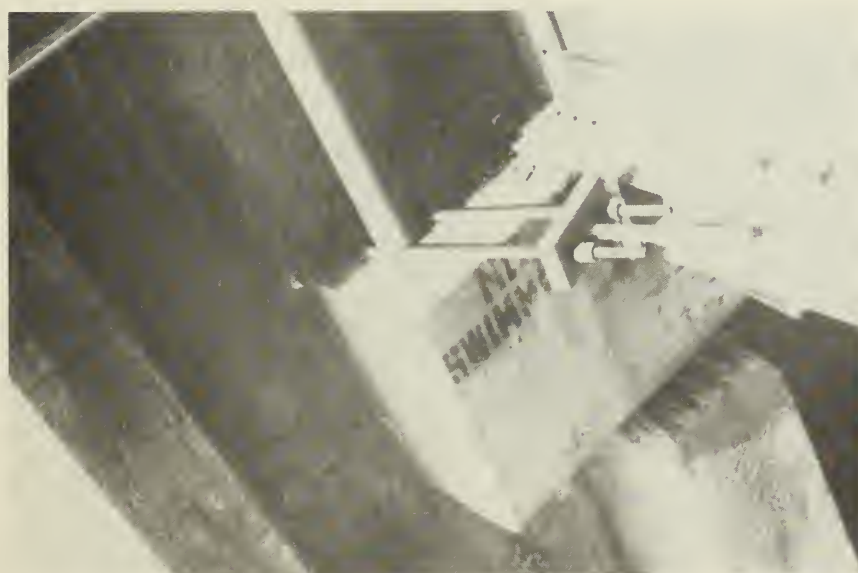
PHOTO 4 Restrainer unit at Abutment 6.
Br. No. 37C-166

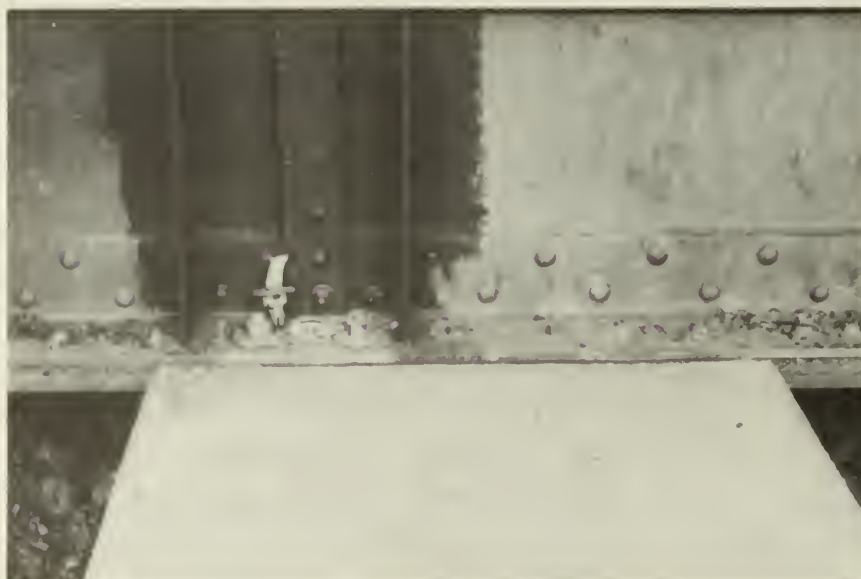
PHOTO 5 Anchor bolts sheared off at Abutment 1. Br. No. 37C-166

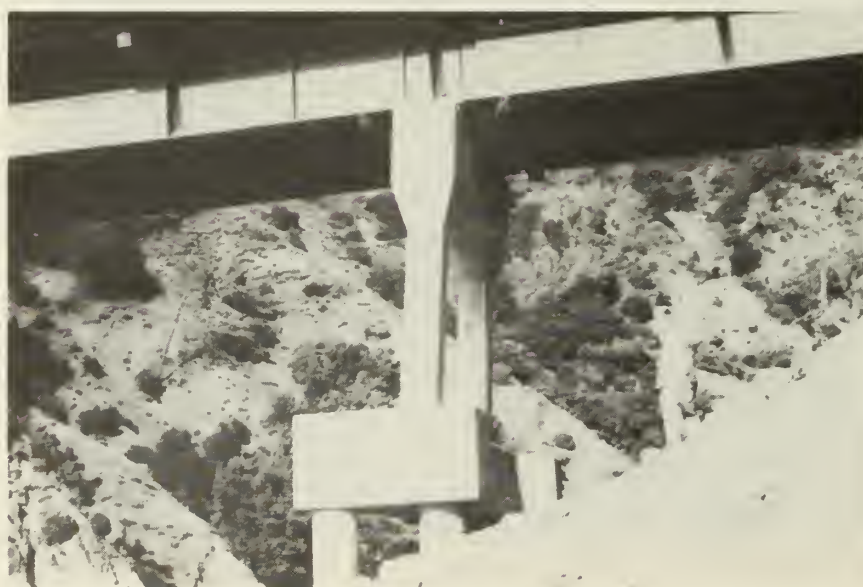
PHOTO 6 Pier 2 knocked out of plumb. Br. No. 37C-166

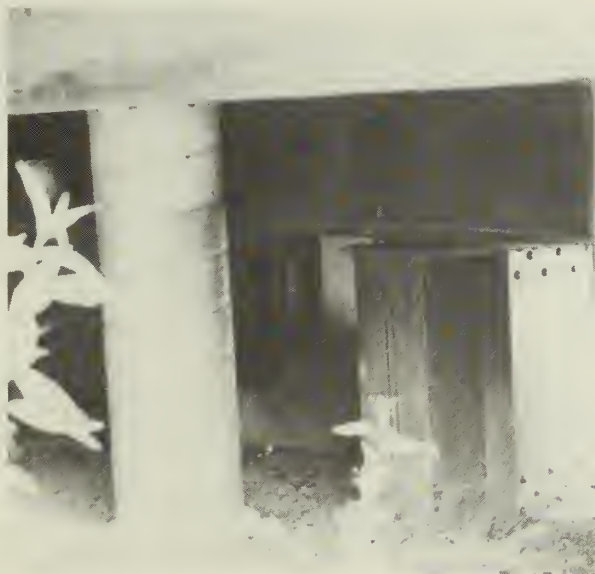
PHOTO 7 End slab span at Abutment 1 restrains
timber deck movement. Br. No. 37C-166

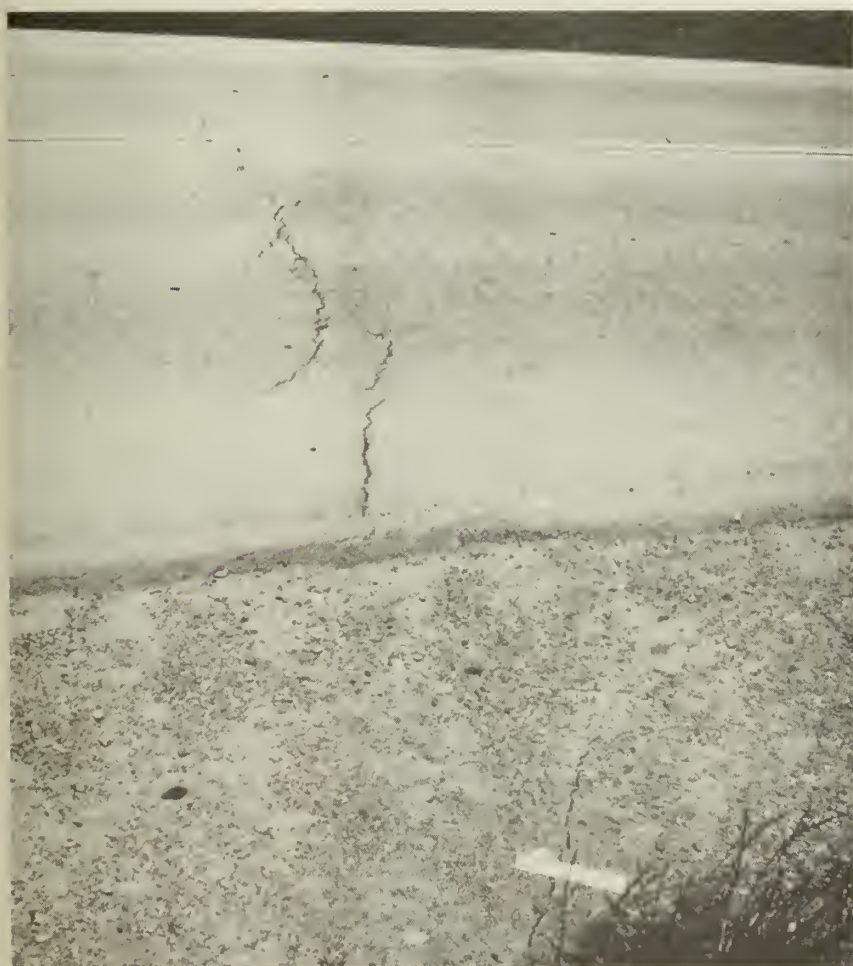
Figure 4. View northeast along trace of Calaveras fault at Shore Road 10 km northeast of Hollister. SHR1 lies in road shoulder off right side of photograph and crosses the trace at an angle of 45° . Cracks in road began after repaving in 1982. White, 15-cm scale in lower right-hand corner indicates location of fresh crack in road shoulder apparently caused by afterslip following the April 24 earthquake (see Figure 5).
